Numerical investigation on damage performance of a reinforced concrete structure subjected to machine loads

Memduh Karalar ^{a,*} 💿, Murat Çavuşli ^a 💿

^a Department of Civil Engineering, Zonguldak Bülent Ecevit University, İncivez, 67100 Zonguldak, Turkey

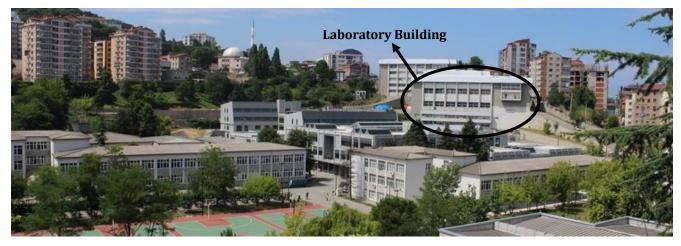
Fig. 1. View of the Laboratory Building.

Zonguldak Bulent Ecevit University Laboratory was constructed in Zonguldak province in 2009. It is located in the University campus. It is a reinforced concrete (RC) building and it has 4 different flats. First and second flats have very heavy machines which are located on the floors and these machines are very critical for civil engineering technology. All flats have coffered slabs and these coffered slabs have very different thicknesses and mechanical properties from each other. These thicknesses are 12 cm, 14 cm, 15 cm, and 18 cm, respectively. Moreover, concrete classes of these slabs are C18, C20 and C22, respectively. Zonguldak Bulent Ecevit University Laboratory building is shown in Fig. 1. Moreover, views of the laboratory building projects are presented for the first floor, second floor, third floor and fourth floor in Fig. 2.

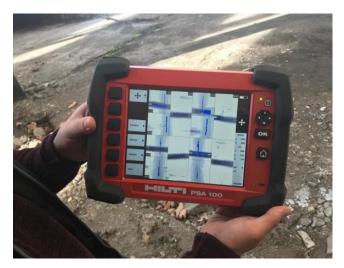
Fig. 5. Examination of carrying elements with X-ray device.

Examination of 3D damage performance of reinforced concrete (RC) buildings is very important for civil engineers. Firstly, x-ray devices were used to determine current situation of the rebars (Fig. 5). Then, the compressive

strength of the carrying elements was determined with the Schmidt hammer device. With this device, 15 strokes were applied to each carrying element and concrete classes of these elements are obtained by this device. According to numerical analysis results, empty and full situations of collapsed floor are examined and compared with each other (Tables 1-8). In Tables 1-4, performance analysis results are shown for empty situation of the floor in detail. Moreover, 3D performance results are presented for full situation which there are machine loads on the floor in Tables 5-8. In the numerical results, empty situation of the floor is named as Case 1 and other situation is named as Case 2.
