Research Article

Influence of nano-modification on mechanical and durability properties of cement polymer anticorrosive coating

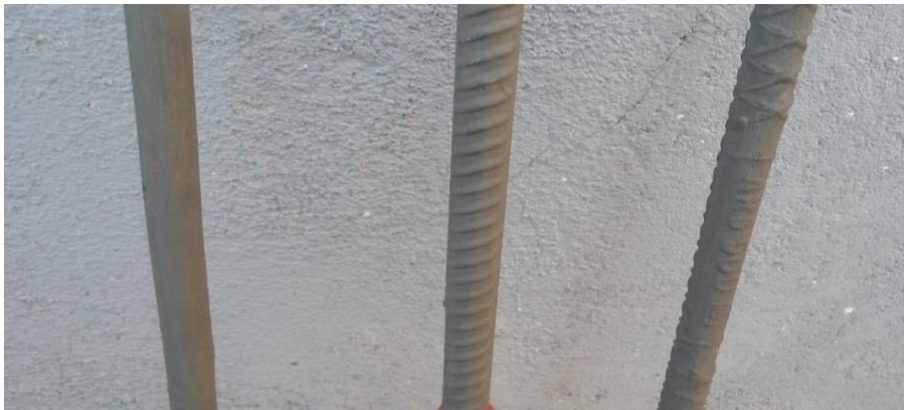
Fig. 4. View of nano-modified cement polymer anticorrosive coated rebars.

The process involves the removal of rust and scales from the steel rebars by hard wire brush and application of coatings by brushing (Shanmugapriya et al., 2015). The nano-modified CPAC was prepared by incorporating 5 gram of Nano Titanium Dioxide (Nano TiO₂) in 1 litre of CPAC. Fig. 3 shows the sequence of the coating process and Fig. 4 shows the view of coated rebars.

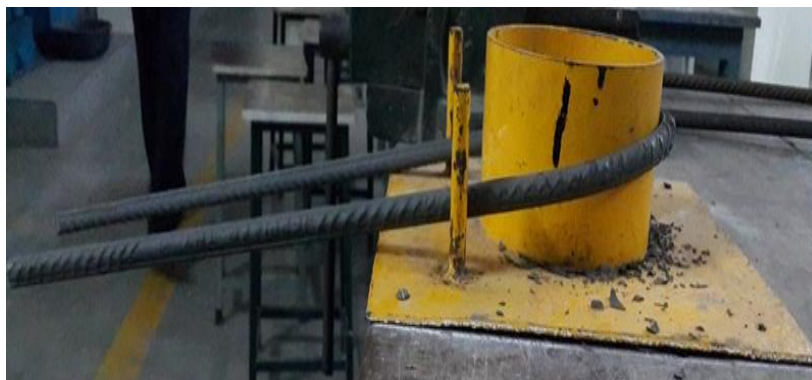
Fig. 10. Coating flexibility test in progress.

coated rebars of 16 mm diameter and 1 m length were used in the test. The coated rebar was positioned in bar bending arrangement such that the longitudinal ribs and the mandrel radius are in 90° planes. “The rebars were bent around 150 mm diameter mandrel to 180° after a rebound with suitable levers. Thermal equilibrium of 240±20°C was maintained during the test”. Fig. 10 shows the CFT test setup.

Three specimens of nano-modified CPAC rebars were subjected to CFT. It was noticed that for the specimen subjected to the test, cracking and disbondment of the coating was observed on both outside and inside radius of the 180° bent rebar. According to BIS and ASTM codal provisions, no cracking of the coating shall be visible to a person with a normal or corrected vision on the outside radius of 180° bend rebars. Therefore the coating has to be applied after cutting and bending operation is over.

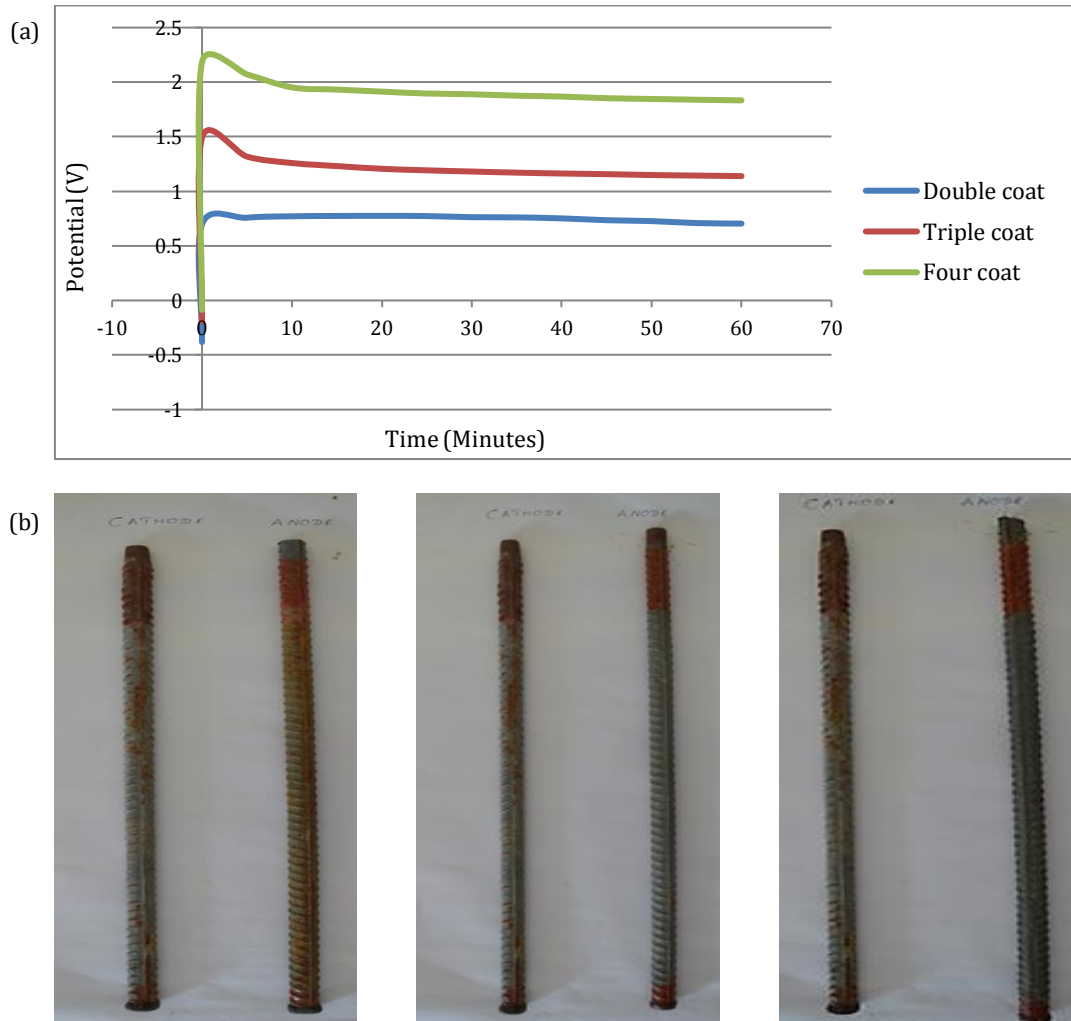
Fig. 12. (a) Potential vs time behaviour of double, triple and four coated Nano TiO₂ modified CPAC rebar; (b) Two, three and four coated specimen after subjected to applied voltage test.

Table 6 shows that in a double-coated specimen, there was no evaluation of hydrogen gas at the cathode and few rust spots at the anode have been observed. In triple coated specimen, there was no evaluation of hydrogen gas at the cathode and two to three rust spots have been observed in the anode. In four coated specimen, there was no evaluation of hydrogen gas at the cathode and no rust spot at the anode. Fig. 12(a) shows potential vs time behaviour of double, triple and four coated Nano TiO₂ modified CPAC rebar.

For double-coated rebar, there was an increase in potential values of 0.682V observed immediately upon impressing 2V from Open Circuit Potential of - 0.386 mV. Afterwards, there is a similar potential value until the

end of the test period. For triple coated rebar there was an increase in potential values of 1.482 mV observed immediately upon impressing 2V from Open Circuit Potential of - 0.192 mV. It was observed that there was a decrease in potential value for 5 minutes and afterwards there is a similar potential value until the end of the test period. For four coated rebar there was an increase in potential values of 2.282 mV observed immediately upon impressing 2V from Open Circuit Potential of - 0.082 mV. It was observed that there was a decrease in potential value for the first 10 minutes and afterwards there was a similar potential value until the end of the test period. Fig. 12(b) shows the coated rebars after subjected to AVT.

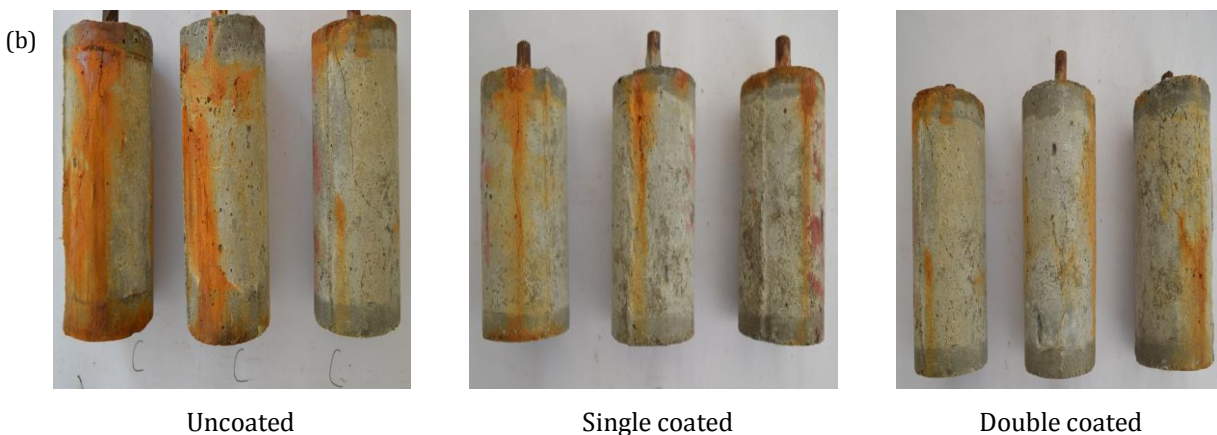
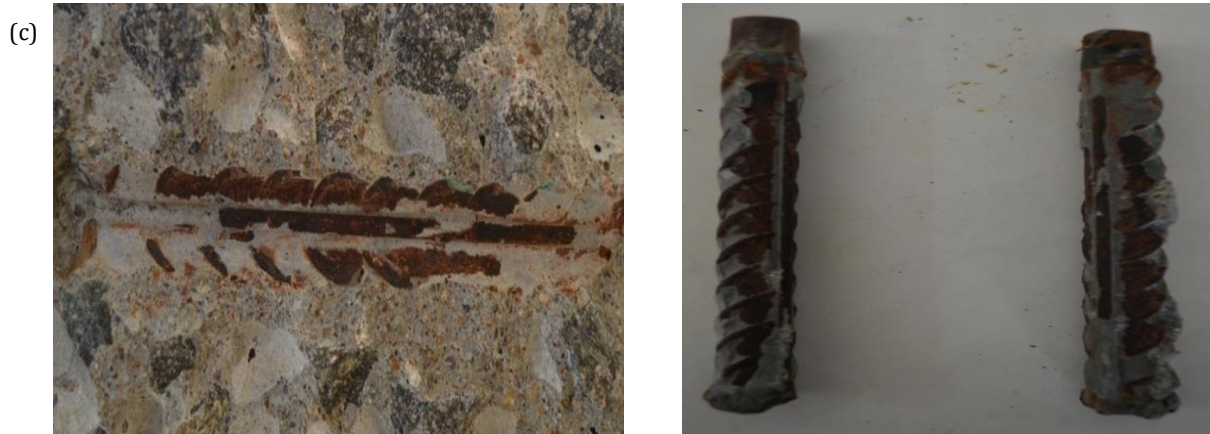
Fig. 14. (continued)

Fig. 14. (a) Comparison of cracking time for nano-modified CPAC coated (single and double) and uncoated rebar in control concrete; (b) Cracked specimens (uncoated, single and double coated) after subjected to accelerated corrosion test; (c) Condition of concrete and coated rebar at the end of accelerated corrosion test.

Fig. 14(a) shows the comparison of cracking time for uncoated and (single and double) coated rebars in control concrete. It was observed that for all the coated rebars, time to cracking was higher when compared to uncoated control rebars. There was an appreciable increase in cracking time for double-coated Nano TiO₂ modified cement polymer anticorrosive coated rebars of the order of 2 times as compared to uncoated rebars. Cracking time for single coated Nano TiO₂ modified cement polymer anticorrosive coated rebar was 1.6 more than uncoated rebar.

Fig. 14(b) shows the condition of cracked specimens after completion of ACT. The specimens were broken open and observations were noted. Fig. 14(c) shows the

condition of the coated rebar and concrete at the end of the test. It was observed that the uncoated rebars were corroded more and the coating is more adhesive to the concrete than rebar.
