Challenge Journal of

CONCRETE RESEARCH LETTERS

Vol.15 No.3 (2024)

A different approach for green concrete production: Determination of the effect of e-waste and waste rubber powder on durability properties of concrete 69–81

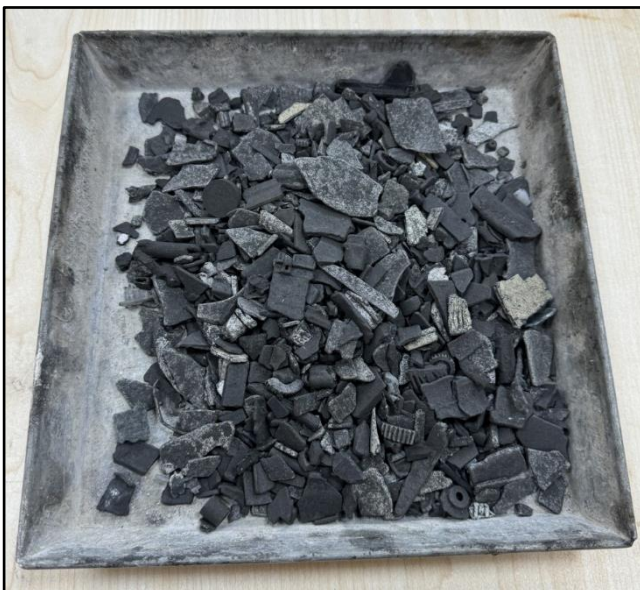
**Fig. 1.** Image of e-wastes.

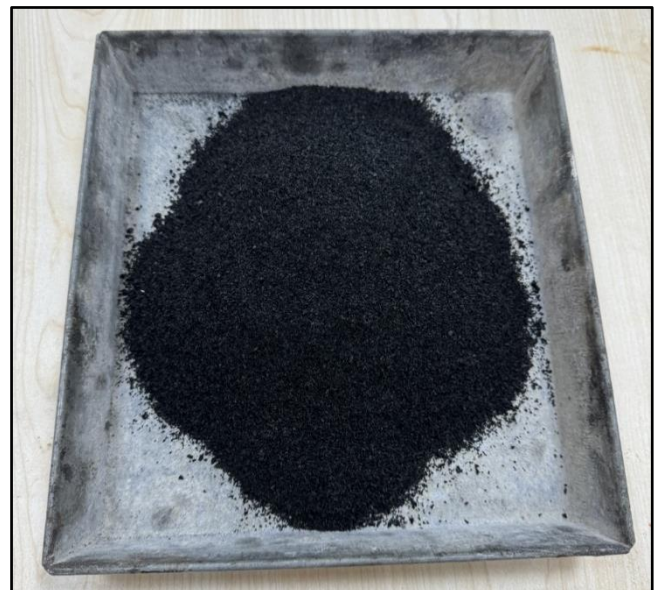
**Fig. 2.** Image of waste rubber powders.

Waste rubber powder, which was utilized instead of cement, was obtained from Cemer Company (İzmir/TR). The visual of the waste rubber powder is presented in Fig. 2. The grain size distribution of waste rubber powder is given in Fig. 3.

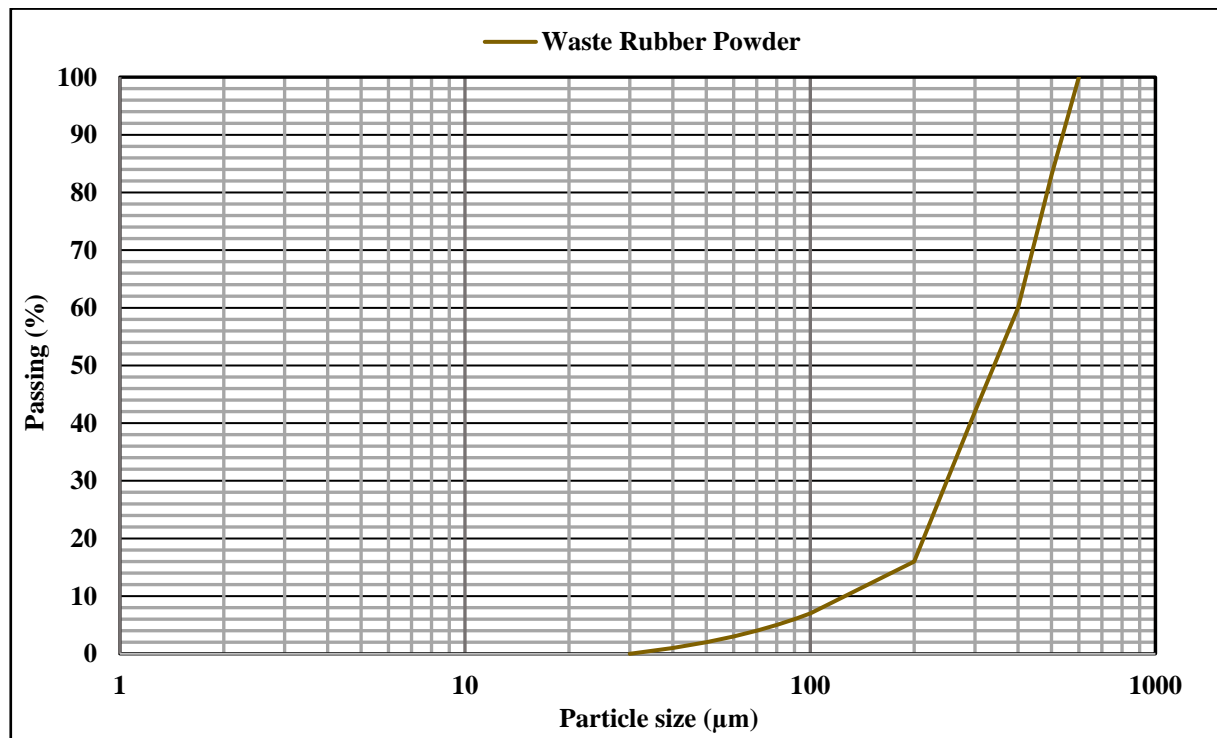
Fig. 3. Particle size distribution of waste rubber powder.

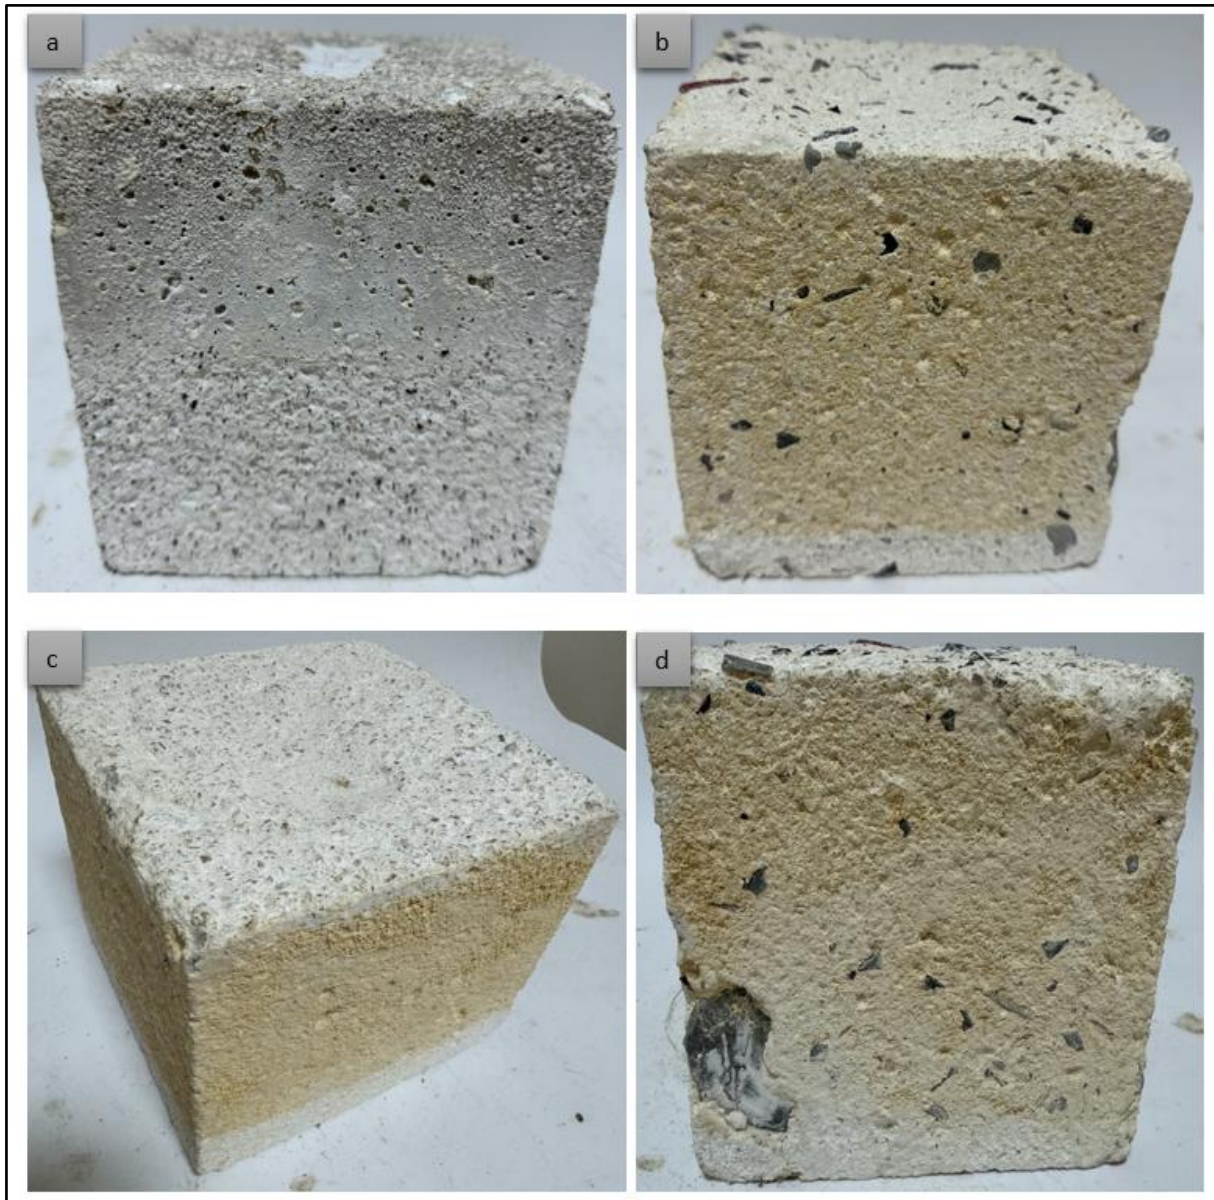
Fig. 7. Images of concretes exposed to acid attack for 90 days:
 (a) 5% waste rubber powder added concrete (P5E0/90);
 (b) 5% waste rubber powder and 5% e-waste added concrete (P5E5/90);
 (c) Control concrete (C/90); (d) 10% e-waste added concrete (P0E10/90).

Fig. 7 presents the visual results of the concretes subjected to acid attack for 90 days. Accordingly, the visual damages of the specimens displayed a similar trend to the weight and compressive strength losses. It is clearly observed in a and b images that concrete with 5% waste rubber powder (P5E0/90) and concrete with 5% waste rubber powder-5% e-waste (P5E5/90), which are the concretes with the lowest weight and compressive strength losses, are visually more resistant to acid exposure. Control concrete (C/90) and concrete containing 10% e-waste (P0E10/90) suffered more visual damage (surface peeling, discolouration, abrasion, exfoliation) as a result of acid attack (visible in images c and d). This coincided with the weight and compressive strength losses.

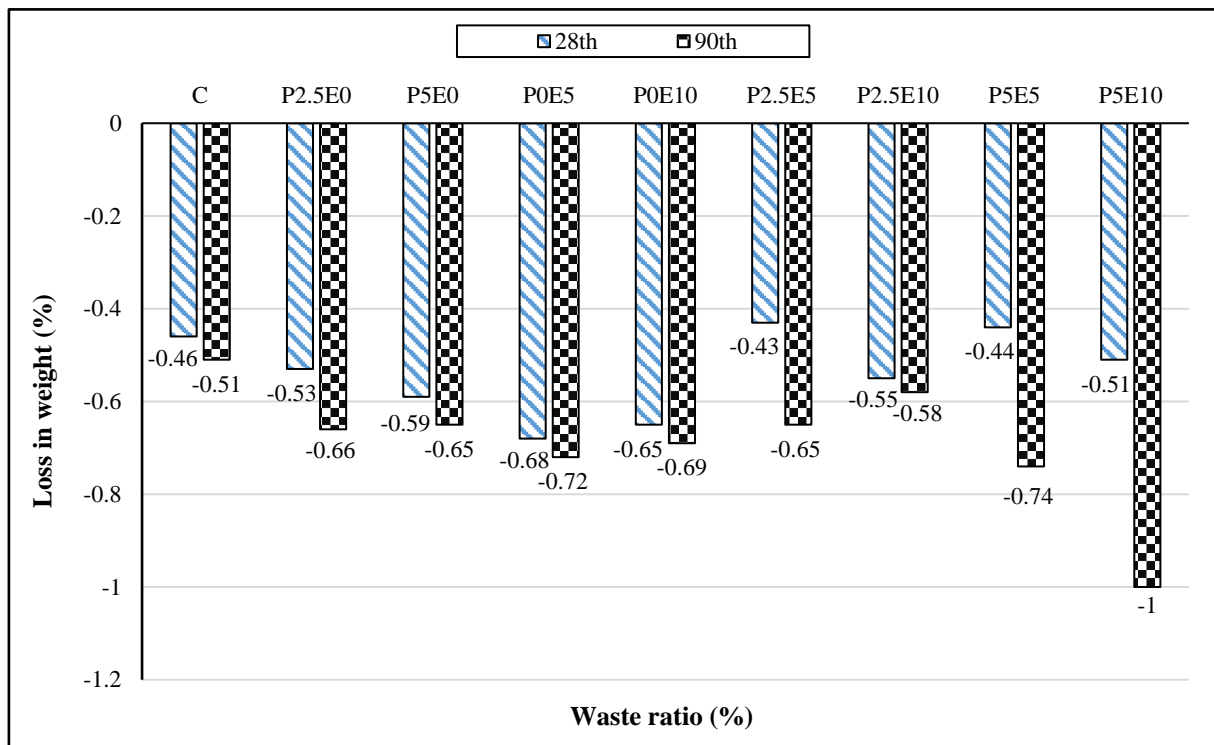
Fig. 8. Loss in weight results of concretes after sulfate attack.

The results obtained are remarkable and engaging for the literature and all of the concrete groups experienced weight increases instead of weight losses. For example, when the 90-day results were analyzed, the highest weight loss/increase was observed in concrete containing 5% waste rubber powder-10% e-waste (P5E10/90) and concrete containing 5% waste rubber powder-5% e-

waste (P5E5/90) with values of -1% and -0.74%, respectively. When the sulfate attack increased from 28 days to 90 days, the weight increases in the concretes also increased. Sulfate attack is a complex mechanism with mechanical, chemical and physical processes and negatively affects the properties of concrete (Tanyildizi 2016; Ikumi et al. 2019). It is believed that sulfate ions blocked the pores of the concretes and caused an increase in weight. In addition, it is considered that the high absorption ability and deformation capacity of both waste types in the face of energy increase, which will reduce the entry and reactivity of sulfate ions into the internal structure, are effective in this situation (Onuaguluchi and Banthia 2019). It was determined that the weight losses/increases after the sulfate attack were similar to each other and very close to 0. This showed that concretes produced with waste rubber powder and e-waste can be resistant to sulfate attack.

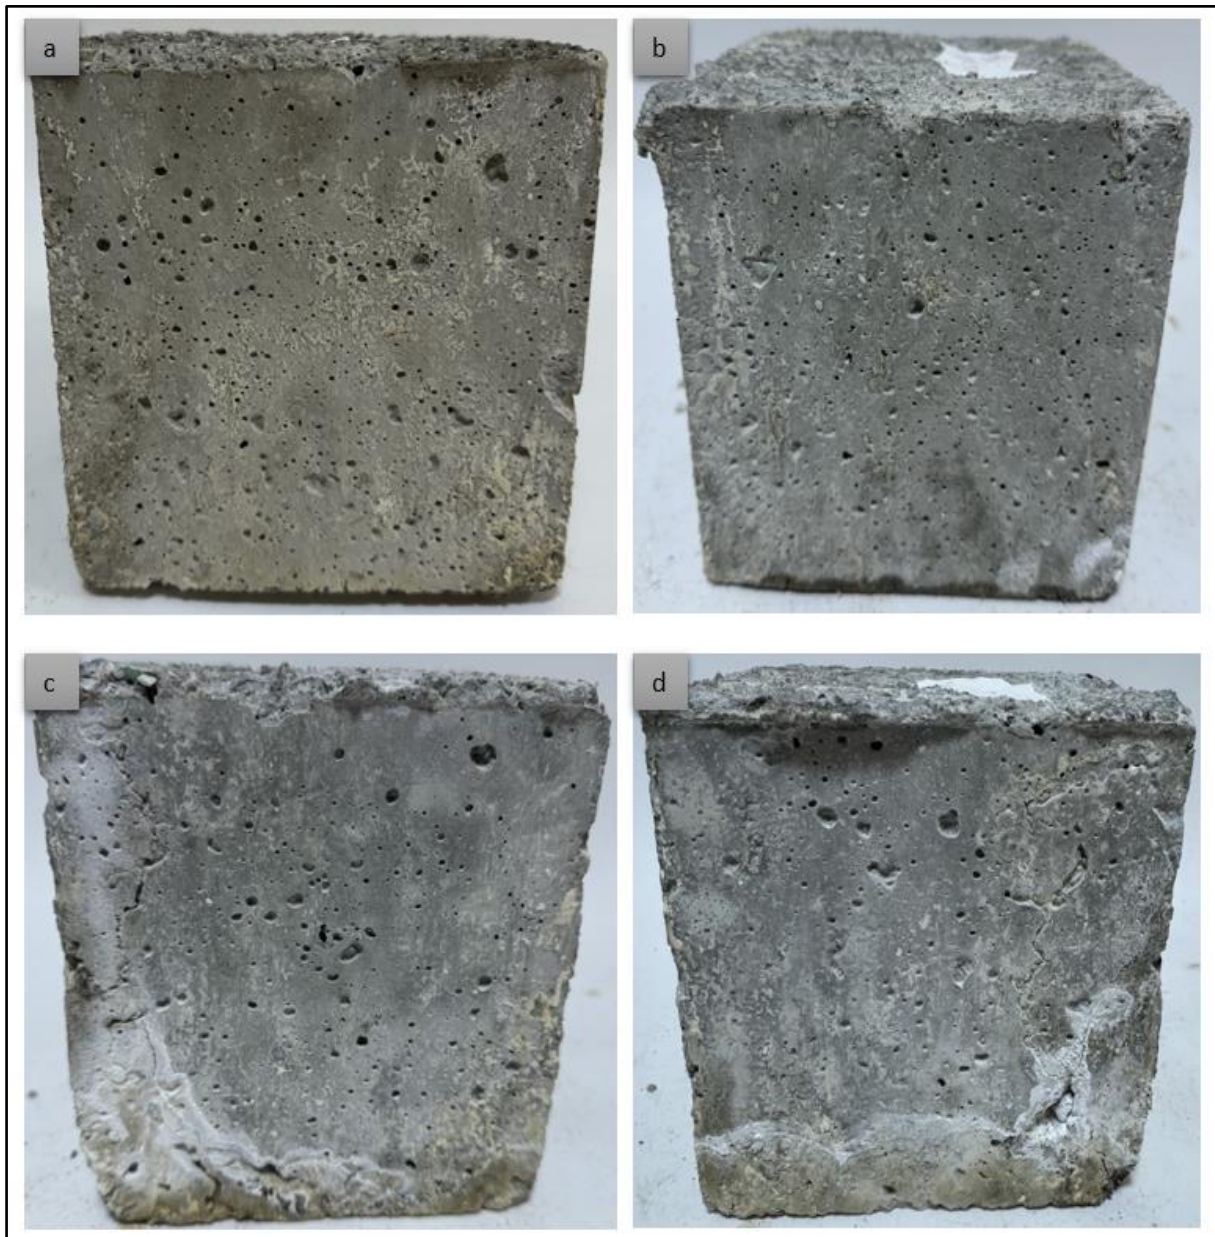
Fig. 10. Images of concretes exposed to sulfate attack for 90 days:
 (a) 5% waste rubber powder and 10% e-waste added concrete (P5E10/90);
 (b) 5% waste rubber powder and 5% e-waste added concrete (P5E5/90);
 (c) 5% e-waste added concrete (P0E5/90); (d) 10% e-waste added concrete (P0E10/90).

Fig. 10 presents the visual results of concretes exposed to sulfate attack for 90 days. It was observed that 5% waste rubber powder-10% e-waste concrete (P5E10/90) and 5% waste rubber powder-5% e-waste

concrete (P5E5/90), which differed from other concretes in a positive way in terms of both weight and compressive strength loss, did not suffer any significant damage after sulfate attack, as can be observed in a and b images. However, concrete with 5% e-waste (POE5/90) and concrete with 10% e-waste (POE10/90) were severely damaged after sulfate attack (chipping, peeling, cracking, discolouration at the corners) as can be clearly visualised in images c and d. The results of the visual analysis were similar to the weight and compressive strength losses obtained after sulfate attack.

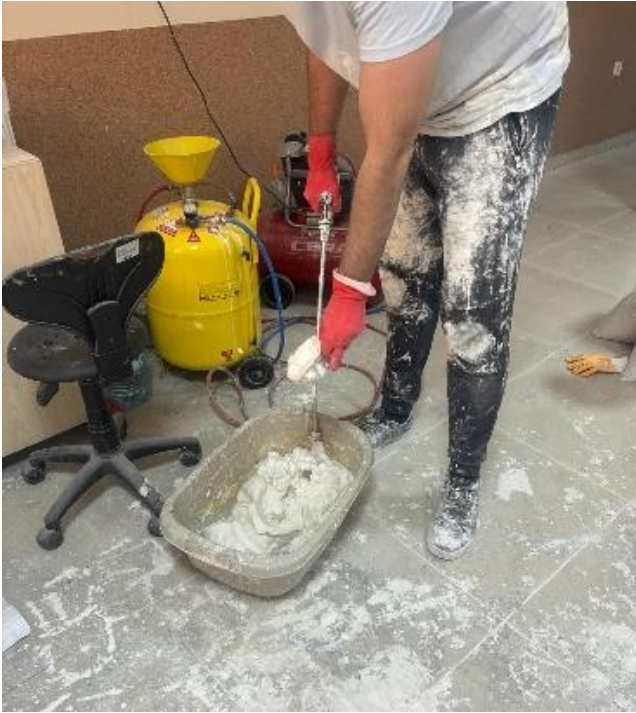
Fig. 2. Foamed concrete production.

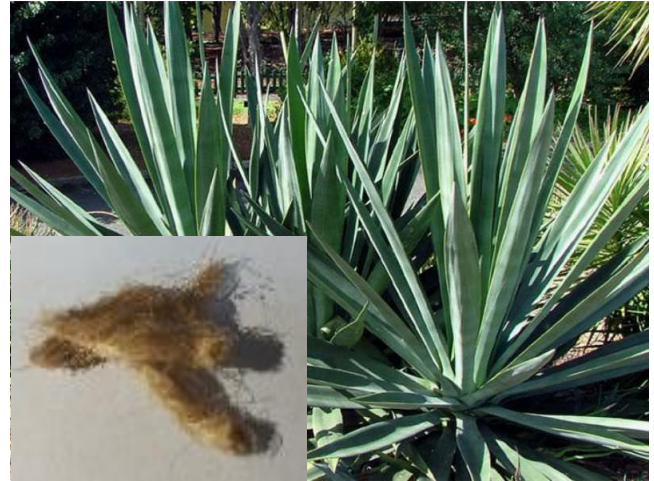
Fig. 3. Agave sisalana plant and sisal fiber.

in Fig. 3. The physical and chemical properties of sisal fiber are given in Table 2.

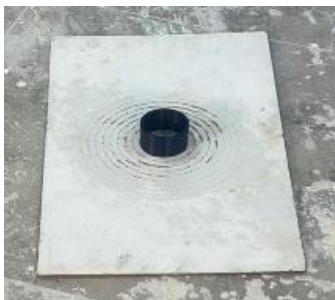
Fig. 4. The spread diameter test.

The mini-slump test was performed to measure the spreading diameter of fresh concrete, according to TS-EN 1170-1 (TS-EN-1170-1 1999), as shown in Fig. 4.

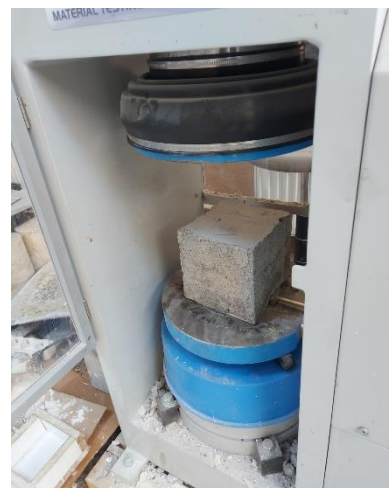
Fig. 5. The compressive strength test.

The cubic samples with dimensions of 150x150x150 mm were prepared to determine the compressive strength of foamed concrete. The samples were tested by TS-EN 12390-3 (TS EN 12390-3 2002). The compressive strength test is presented in Fig. 5. The samples were kept in the mold for 16 hours and were then placed in curing pools at 20 °C. Compressive strength test samples were tested at the end of 7 and 28-day cures.

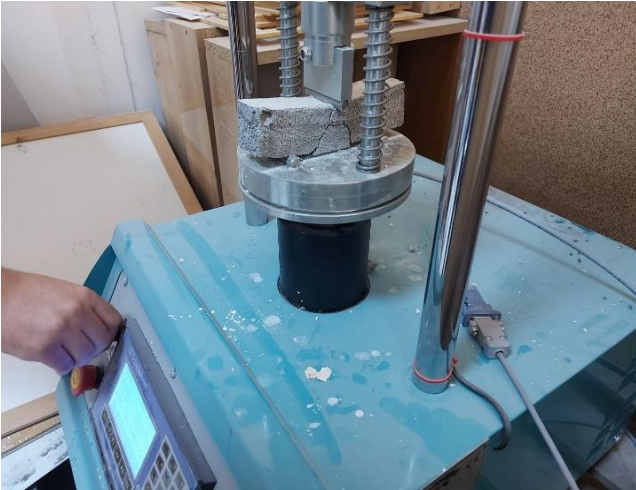
Fig. 6. The flexural strength test.

Prismatic samples measuring 40x40x160 mm were prepared for the flexural test. The samples were tested according to the TS-EN 12390-5 (TS EN 12390-5 2019), as seen in Fig. 6. The density of foam concrete was measured according to TS-EN 12390-7 (TS-EN-12390-7 2010).

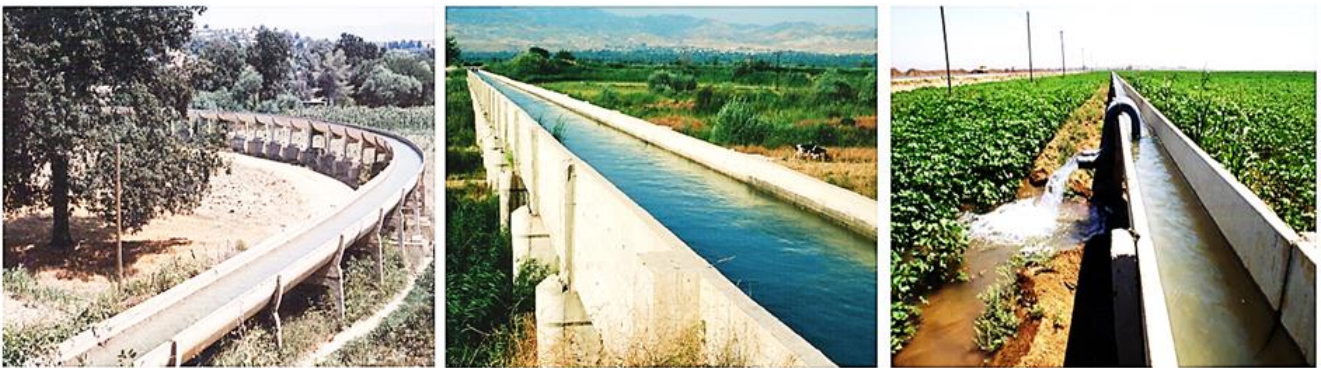
Fig. 1. Prefabricated irrigation flume samples (URL 1; Sepetçioğlu et al. 2018).

signed as small water channels. Generally, their cross-section can be elliptical or circular (Fig. 1). An important feature of these flumes is that the water level can be kept at the desired level by changing the foot heights. In this way, the slope of the channel is adjusted to ensure that the water remains at the desired level. This adjustment is made depending on irrigation requirements and the topography of the land. These channels are used to provide water to farmers according to the water demand system or unit field unit water system to meet irrigation needs. These systems ensure the effective distribution of water and regular irrigation of agricultural lands. In addition, balanced distribution of water increases agricultural productivity by meeting the water needs of plants (Özbek 1987). They are used for various purposes such as directing, storing, transporting or distributing water. Canals are widely used in areas such as agricultural irrigation, drinking water supply, industrial processes, flood control and hydroelectric power generation. These structures contribute to the effective and efficient management of water resources (Vanani and Ostad-Ali-Askari 2022). Canals used for agricultural irrigation support food production by increasing agricultural productivity. Drinking water channels meet the water needs of cities and meet a basic need for a healthy life. Therefore, channel structures are of fundamental importance in water management and infrastructure projects.

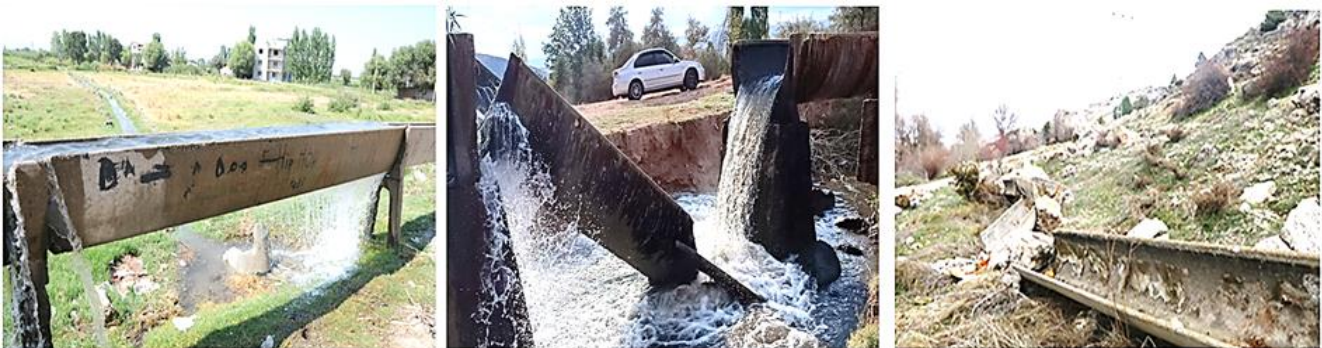
Fig. 2. Damages occurring in various irrigation channel:
(a) Manisa; (b) Hasandede/Kırıkale; (c) Kahramanmaraş (URL 2; URL 3).
