Research Article

Monitored structural behavior of a long span cable-stayed bridge under environmental effects

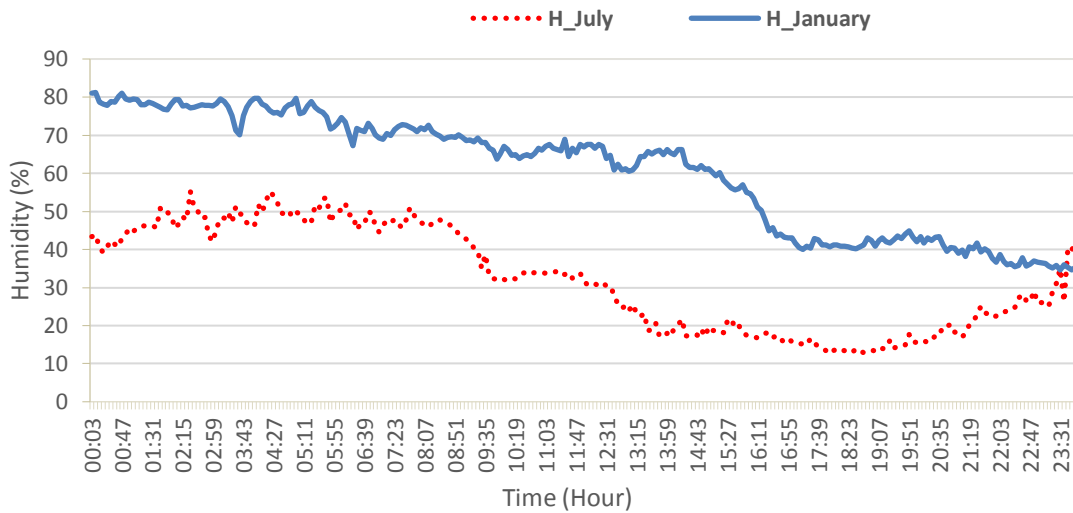
(a) Daily temperature

(b) Daily humidity

(c) Daily wind speed

Fig. 4. Variations of air temperature, humidity and wind speed on July 31, 2015 and January 1, 2016.

The cables, pylons and deck behaviors under environmental effects such as air temperature, humidity and wind speed are investigated in this section. The forces and acceleration responses of bridge elements measured from the bridge monitoring system are compared for various environmental meteorology. The data recorded in the hottest summer (July 31, 2015) and the coldest winter (January 1, 2016) days are chosen for the comparisons. The daily variations of air temperature, humidity and wind speed with time are shown in Fig. 4. It can be seen from Fig. 4a that air temperature is above 30°C

on July 31 and below 3°C on January 1. The temperature slightly decreases and reaches the minimum in the early morning in both day. The temperature then increases to the maximum in the early afternoon and decreases in the evening and at midnight. The temperature reaches a minimum of approximately 0°C at around 05:00 hrs on January 1 and a maximum of approximately 36°C at around 16:00 hrs on July 31. The relative humidity ratio on January 1 is higher than the ratio on July 31. The humidity decreases and reaches minimum in the evening in both days. Maximum wind speed is observed over 12 m/s on January 1, whereas the maximum wind speeds occur in the afternoon on July 1 and at midnight on January 31. In general, the change in temperature between

The variations of temperature and humidity in January 1 and July 31 are shown in Figs. 4a and 4b. The variation of cable forces with air temperature on July 31 and January 1 are depicted for cables 160, 260, 360 and 451 in Figs. 6 and 7. It can be seen from Figs. 6 and 7 that the values of cable forces slightly change in July 31 and January 1 throughout the day. The cable forces increase and reaches the maximum values in the early morning on January 1, in which temperature has smallest values. Besides cable 160, cables forces recorded in July 31 have maximum values in the afternoon, in which temperature has maximum values.

The design wind speed was taken into account as 33.6m/s (120km/h) at the design stage of the bridge. Variations of wind speed on July 31 and January 1 are shown in Fig. 4c. Maximum wind speed recorded was slightly over 12m/s in January 1. The variation of forces for Cable 160,
