Earthquake performance of collapsed school building under Van-Tabanlı (Mw=7.2) earthquake

Cumhur Cosgun^{a,*}, Atakan Mangir^b

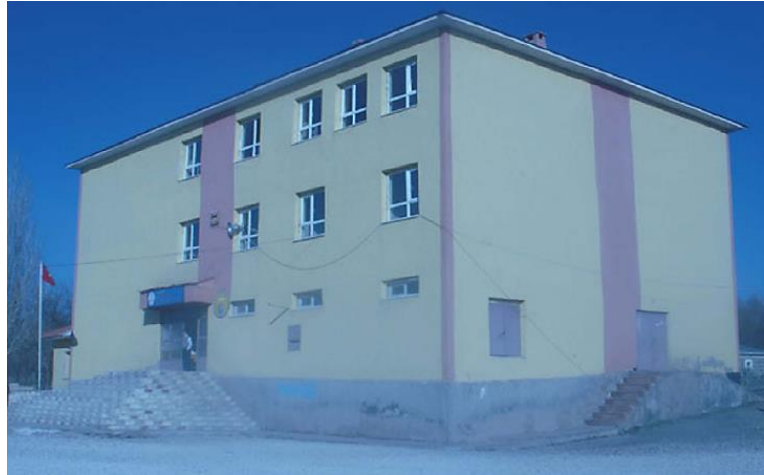
Fig. 3. View of the collapsed school building.

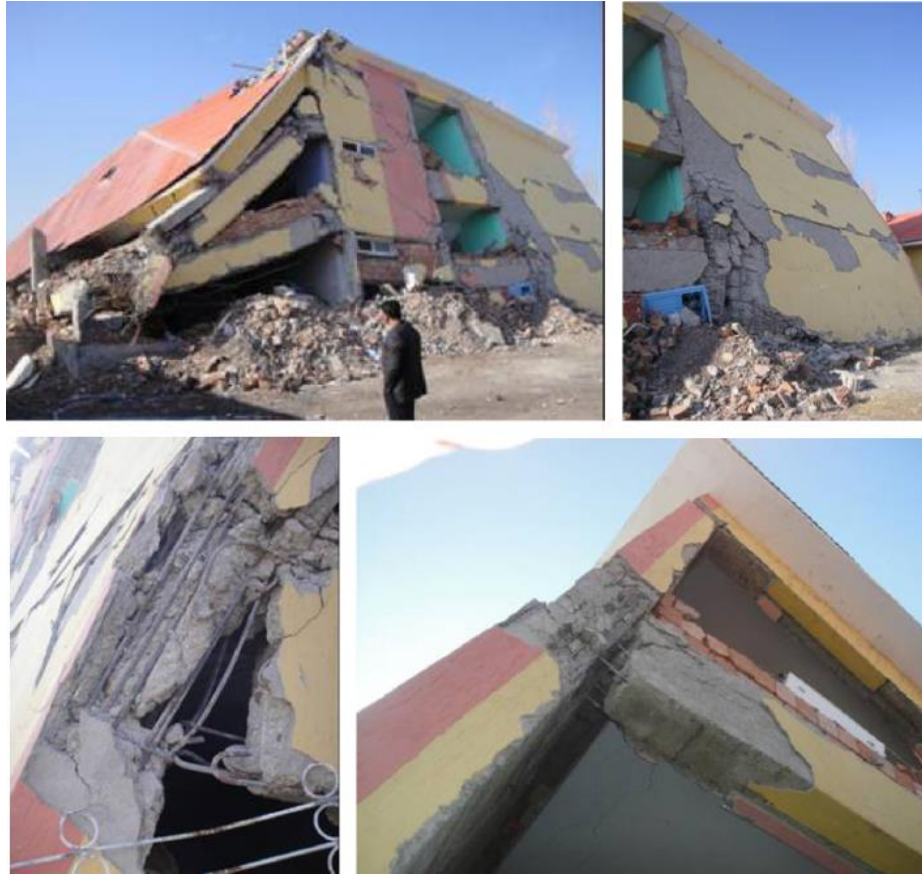
Damage outline of the collapsed building is presented under this chapter. Fig. 6 presents post-earthquake photographs of this collapsed building. Also, in Fig. 7, a close-up photograph of one of the failed shear walls in the building at first floor level is shown. It is observed that the shear

walls were lacking all necessary conditions that are dictated by the related Turkish Seismic Design Code (TSC, 2007). These include inadequate lap splices, poor reinforcement details, insufficient concrete strength and the use of plain reinforcement bars. Some of these deficiencies can also be observed from the buildings in Kütahya region of Turkey after 2011 Simav earthquake (Yön et al., 2013).

Fig. 6. Photos of the collapsed school building.

As will be demonstrated in the following pages, the nonlinear static analysis of the building carried out by assuming the project member sizes and reinforcement details has revealed that the structural system appears to be adequate, in terms of stiffness and strength, to withstand these moderate-level earthquakes without total collapse. However, the deficiencies in reinforcement detailing such as insufficient anchorage of the beam longitudinal bars into the shear walls (see Fig. 6), low stirrup spacing and the lack of hooks of lateral reinforcement, and inadequate lap splices of the longitudinal bars of the shear walls seem to have impaired the efficiency of the shear walls, remarkably (see Fig. 7). The collapse mechanisms encountered in this observation can be compared and discussed with the study on the seismic behavior of a reinforced concrete building collapsed during the 2009 L'Aquila earthquake (Palermo et al. 2014). In 2009 L'Aquila earthquake, some of the buildings were totally collapsed building revealed that most of the columns at the ground story level failed in shear with some evident buckling of the longitudinal bars (no transverse reinforcement in the joint region).

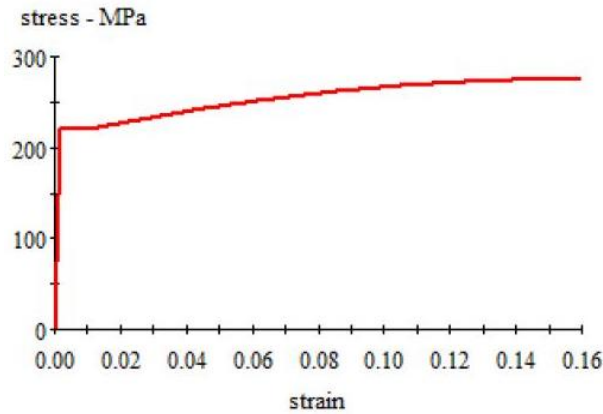
Fig. 10. Stress–strain model with strain hardening for reinforcing steel ($f_y=220$ MPa).

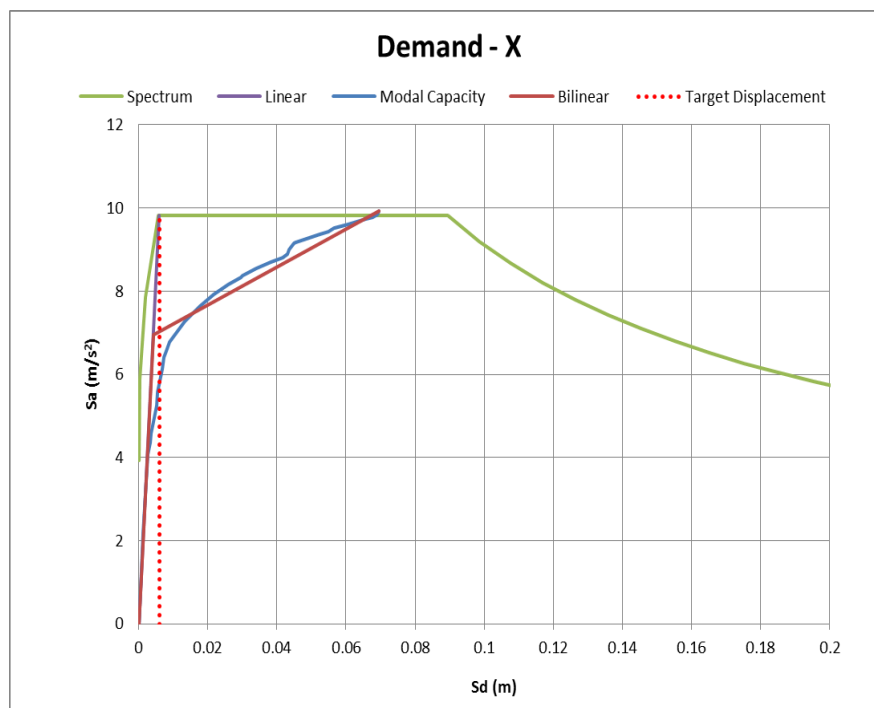
Fig. 11. Deflection demand for PushX case.

In the nonlinear static (pushover) analysis, the behavior of the structure is characterized by the capacity curve that represents the relationship between the base shear force and top displacement. This is a very convenient representation in practice, and can easily be visualized by structural engineers. It is recognized that the structure’s roof displacement is used for the capacity curve because it is widely accepted in practice. The structure is investigated in both orthogonal horizontal directions. Analysis case for x direction was named PushX while PushY was used for y direction. As analysis results, “pushover curves of both cases are converted to modal capacity diagrams and superposed with design earthquake spectrum with bilinear curves. Deflection demand curves for both cases are given in Figs. 11 and 12.

TSC (2007) specifies that the target displacement (S_{di}) gathered from the graph should be increased by multiplying the S_{di} value with modal participation factor (Γ_{i1}) and mode shape roof displacement (Φ_{iN1}) of related mode. The target roof displacements calculated for PushX case was calculated as 0.014 m and it was calculated as 0.040

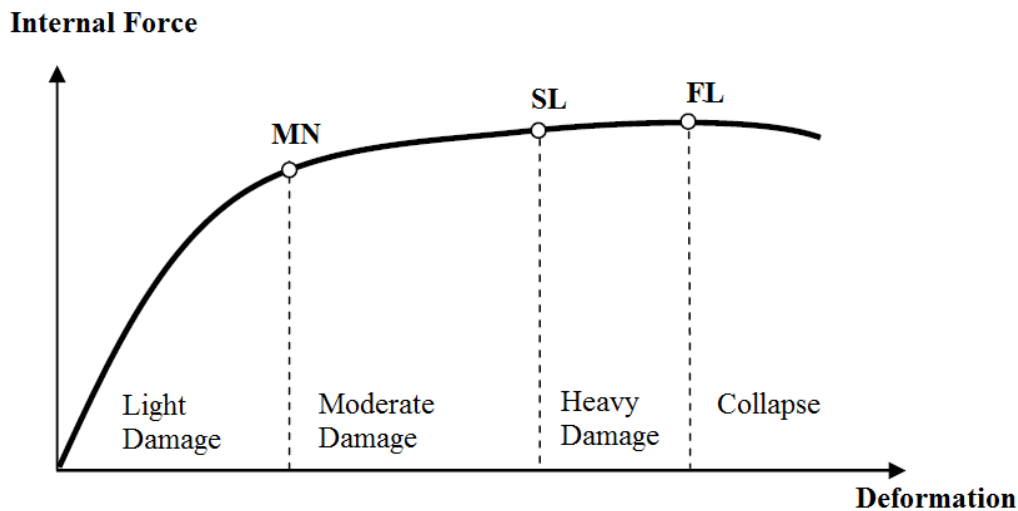
Fig. 14. Performance levels for structural members given in TSC (2007).

The code describes four different performance levels: Light Damage, Moderate Damage, Heavy Damage and Collapse, as shown in Fig. 14.
