Research Article

Assessment of an old roadway bridge under static and seismic loading conditions

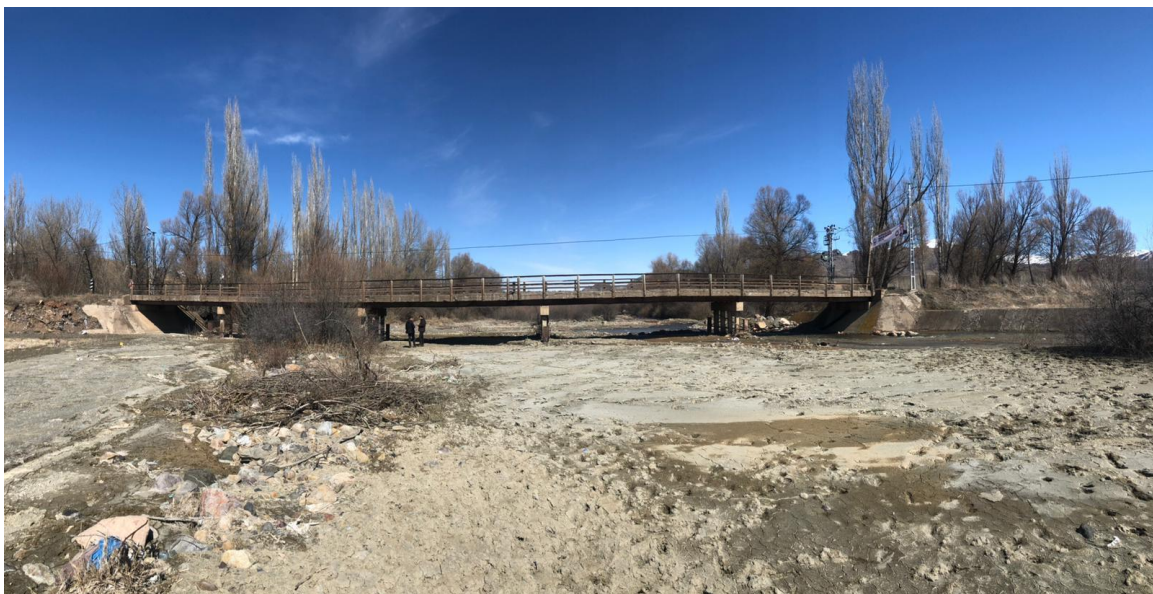
Fig. 4. Photograph of the bridge.
