## Research Article

# Investigation of mechanical properties of steel reinforcements in reinforced concrete structures as a result of exposure to fire

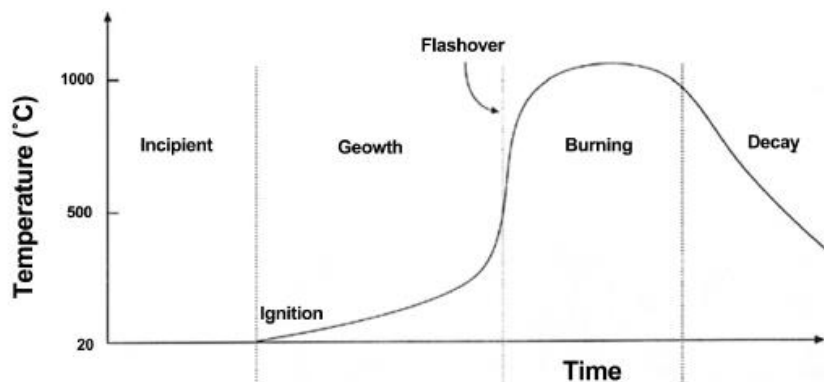
Fig. 1. Classic fire development curve (Polzin 2019).

Basically, fire consists of 5 phases: ignition, development, growth, full growth and extinction (İplikçi 2006; Korol et al. 2015). In a combustion event, the temperature relationship according to the fire stages is given in Fig. 1 (Yazıcı and Koşatepe 2020).

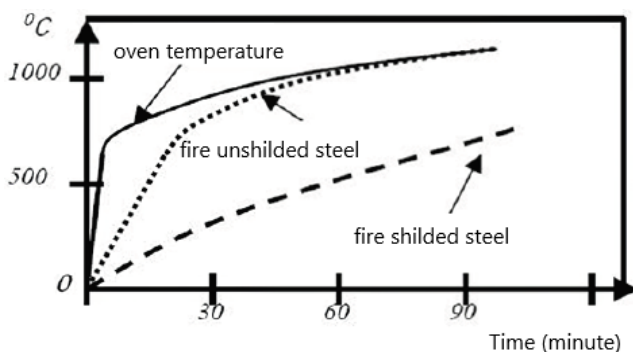
Fig. 2. Time-temperature relationship in structural steels (Lawson 2001).

The variation in the temperature of protected and unprotected structural steels during fire is given in Fig. 2 depending on the time.

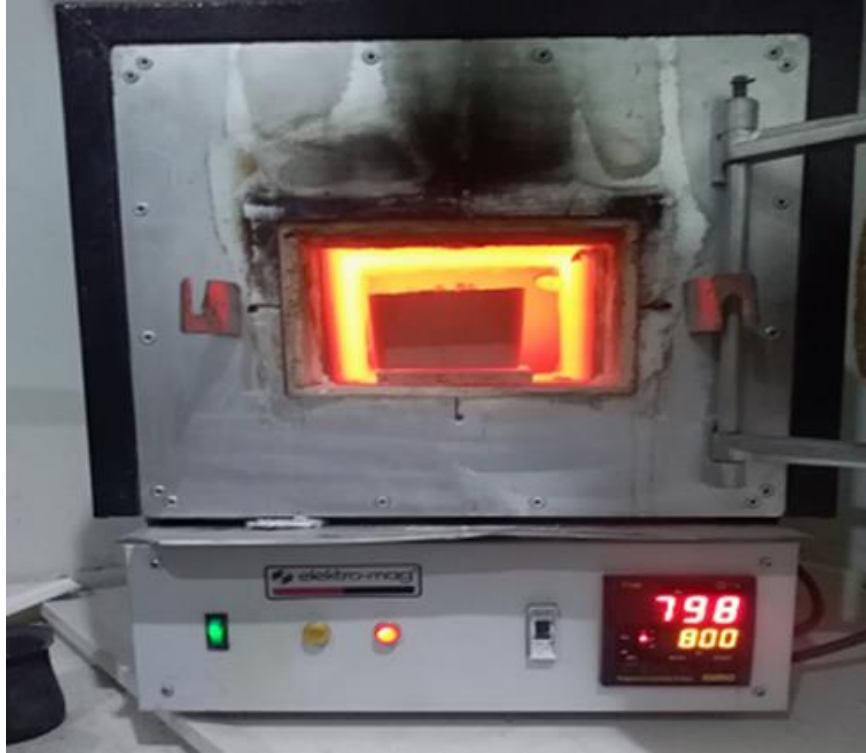
**Fig. 3.** Ash furnace providing desired temperatures.

In this study, TS 708:2010 standards and 8 mm diameter ribbed construction steel were placed in the concrete by leaving a 3 cm spacer. Then, the samples were kept at 600 °C and 1000 °C temperatures for 90 minutes and then allowed to cool. The temperature regulated furnace used to create an environment similar to the fire en-

vironment is given in Fig. 3. The samples were left to cool in the air after the fire as shown in Fig. 4.

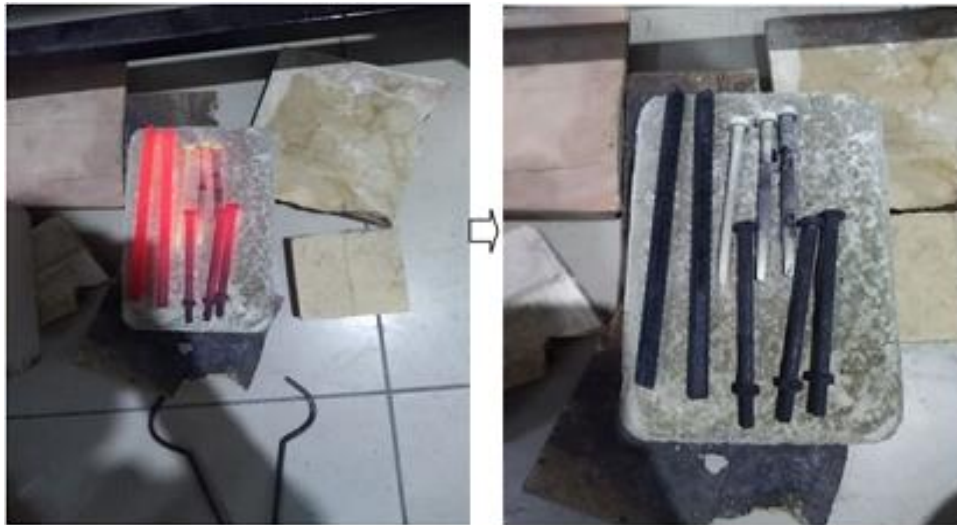
**Fig. 4.** Samples inside and outside the concrete that were left to cool in air.

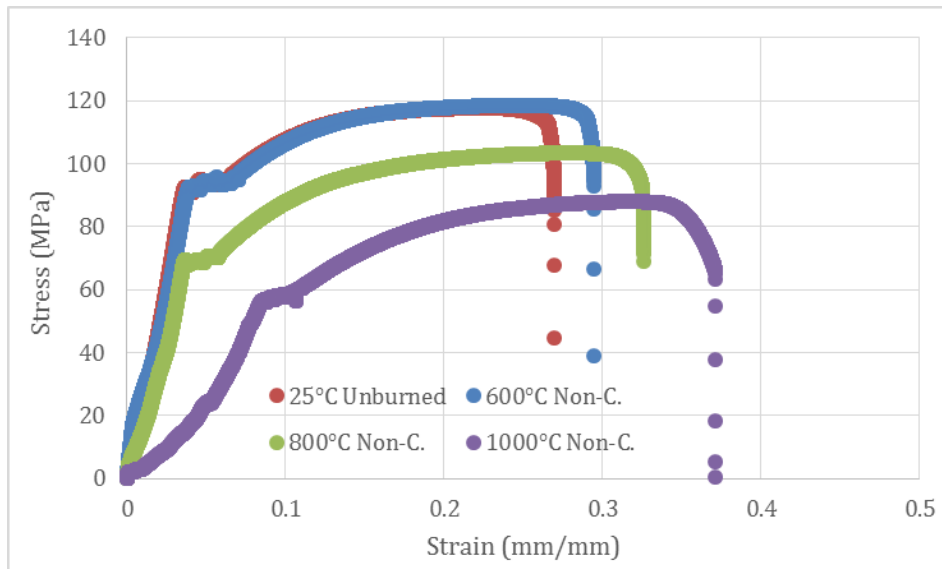
**Fig. 11.** Tensile curves of non-concrete samples.

In Figs. 10 and 11, the samples subjected to the tensile test are handled separately as in-concrete and non-concrete. It is observed that the tensile strengths of both in-concrete and non-concrete samples do not change significantly up to 600 °C. However, at 800 °C and 1000 °C, a very significant decrease in tensile strength is observed for both in-concrete and non-concrete samples. Similarly, while there is no significant change in the ductility of the samples up to 600 °C, it is seen that the ductility

values increase as the temperature increases. In the strength values parallel to the hardness properties, both the tensile strength of the in-concrete samples and the tensile strength of the non-concrete samples decreased. It was determined that the strength of the in-concrete samples decreased more than the strength of the non-concrete samples. Contrary to the hardness and strength values, the ductility values increased as the temperature increased.
